Preserving The Clough Brengle Model 87 Transmitter, Part 2--The Restoration

by, Ron Lawrence, KC4YOY
P.O. Box 3015
Matthews, NC 28106
kc4yoy@carolina.rr.com

The first installment of this two-part story dealt with background on the 1930s Clough-Brengle Company and two of their CW transmitters. Both models were used in the Civilian Conservation Corps camps during the Great Depression. In this final part, Ron continues to tell us about his restoration/preservation of an example of one of them--a model 87 that he had purchased in damaged condition.--wf

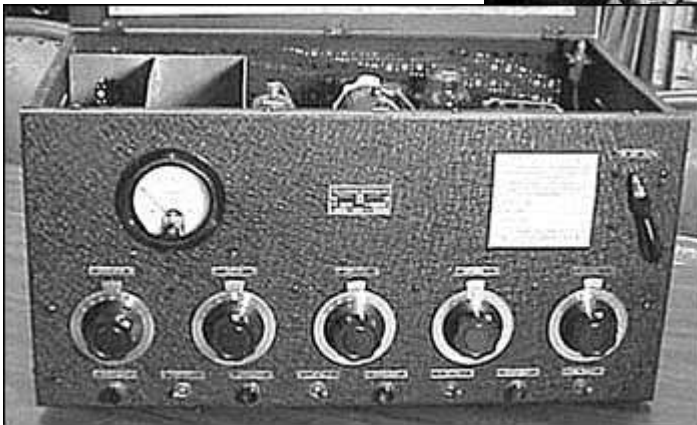
Model 87 front panel after restoration.

One of the problems with vintage communications gear is what to do about the paint on the cabinet. The textured finishes that they were able to apply in the 1930s and 1940s just can't be replicated today--possibly due to EPA-required restrictions in paint formulas.

Some time ago I ran across an item in a 1950s RCA Ham Tips, recommending the use of thinned black paint applied with a balled-up cloth, rubbing the paint color into the textured finish. This will leave just the color and not fill in the depressions. I found another way to accomplish the same thing using Testors Paint Pens (available at most hobby shops) instead of the thinned black paint. I tried it on an old voltmeter with the typical gray color. The result was outstanding, with the original texture clear and sharp under a clean gloss black color.

The paint pen looks like a magic marker, except the tip is spring-loaded. The pen is shaken and pumped to load the paint into the tip, and after a few seconds the paint will begin to flow. The best method I have found is to do a small area, and then use a paper towel to wipe off the excess. As you progress to the next area, wipe the excess off over the previous area to avoid lines.

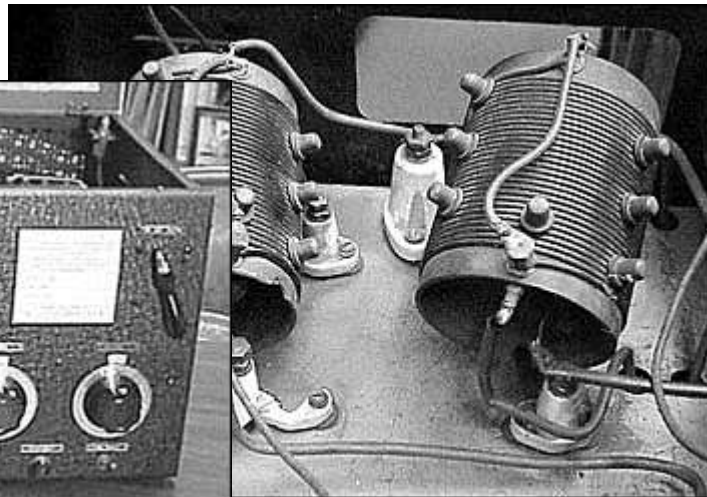
of the antenna coil forms as received.

After the replacement standoffs were installed, I had to do the hard part, which was replacing or repairing the damaged phenolic coil forms. Unfortunately, the broken pieces were missing, so they had to be replaced. Luckily, I was able to locate some matching coil forms, and I decided to patch the originals, cutting pieces from the spare forms and grafting them onto the broken ones.

After some trial and error, I found that my Dremel tool with a thin cut-off disk worked quite well. I cleaned up the broken forms, making a square hole at each location, sanding and filing until the patches fit. I next bridged each patch on the bottom of the coil with another piece from the donor form, out of sight, to give the patch the needed strength to support the coil. Contact cement worked well.

After the cement had set, I used brown plastic wood filler to blend the patches with the original. Sanding and coloring with a brown Magic Marker completed the patch. Mounting holes were drilled, and the coils remounted on the standoffs. Replacement tubes, a pair of 802s and an 83, were obtained and installed.

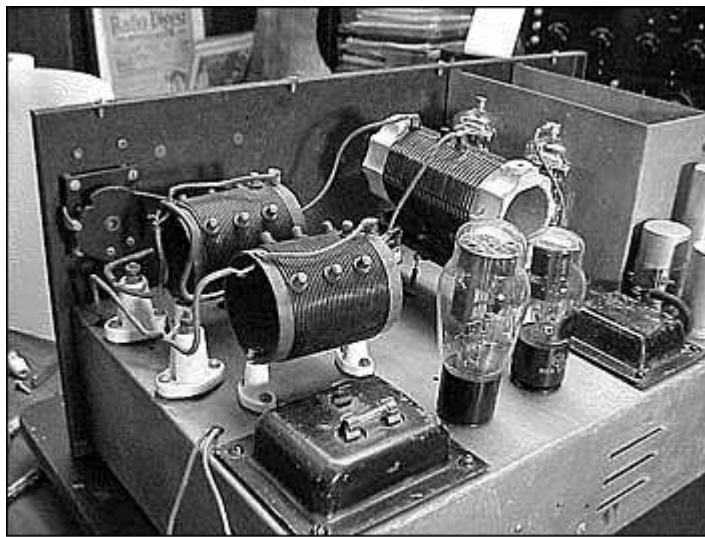
Interior view showing repaired antenna coils.

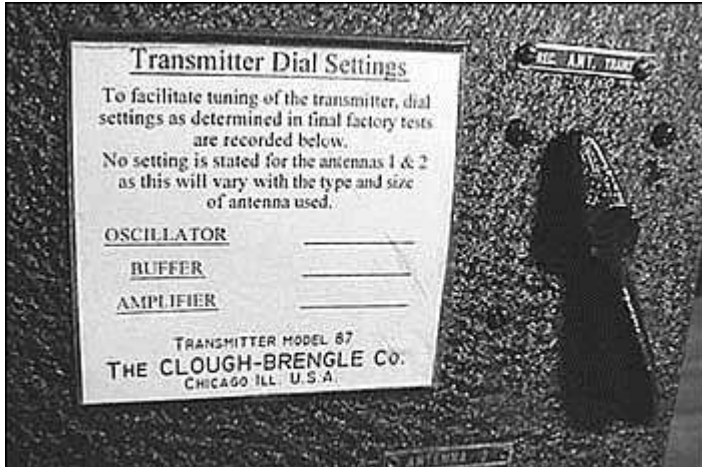
The replicated factory instruction card.

After a little cleaning and polishing of the knobs and dial skirts, I was almost done. The last thing I had to do was come up with something to go in the card holder on the front panel. One of the old CCC operators had told me that the card showed basic tuning instructions. I replicated the factory instructions shown on the Model 4581, another C-B CCC transmitter in my collection. Hopefully this is close to what would have appeared on the original.
